## Electromechanical Rotary Actuator

An electromechanical rotary actuator has been developed as the prime mover for a liquid oxygen modulation valve on the Centaur Vehicle Rocket Engine. The rotary actuator requirements, design, test, and associated problems and their solutions are discussed in this paper.

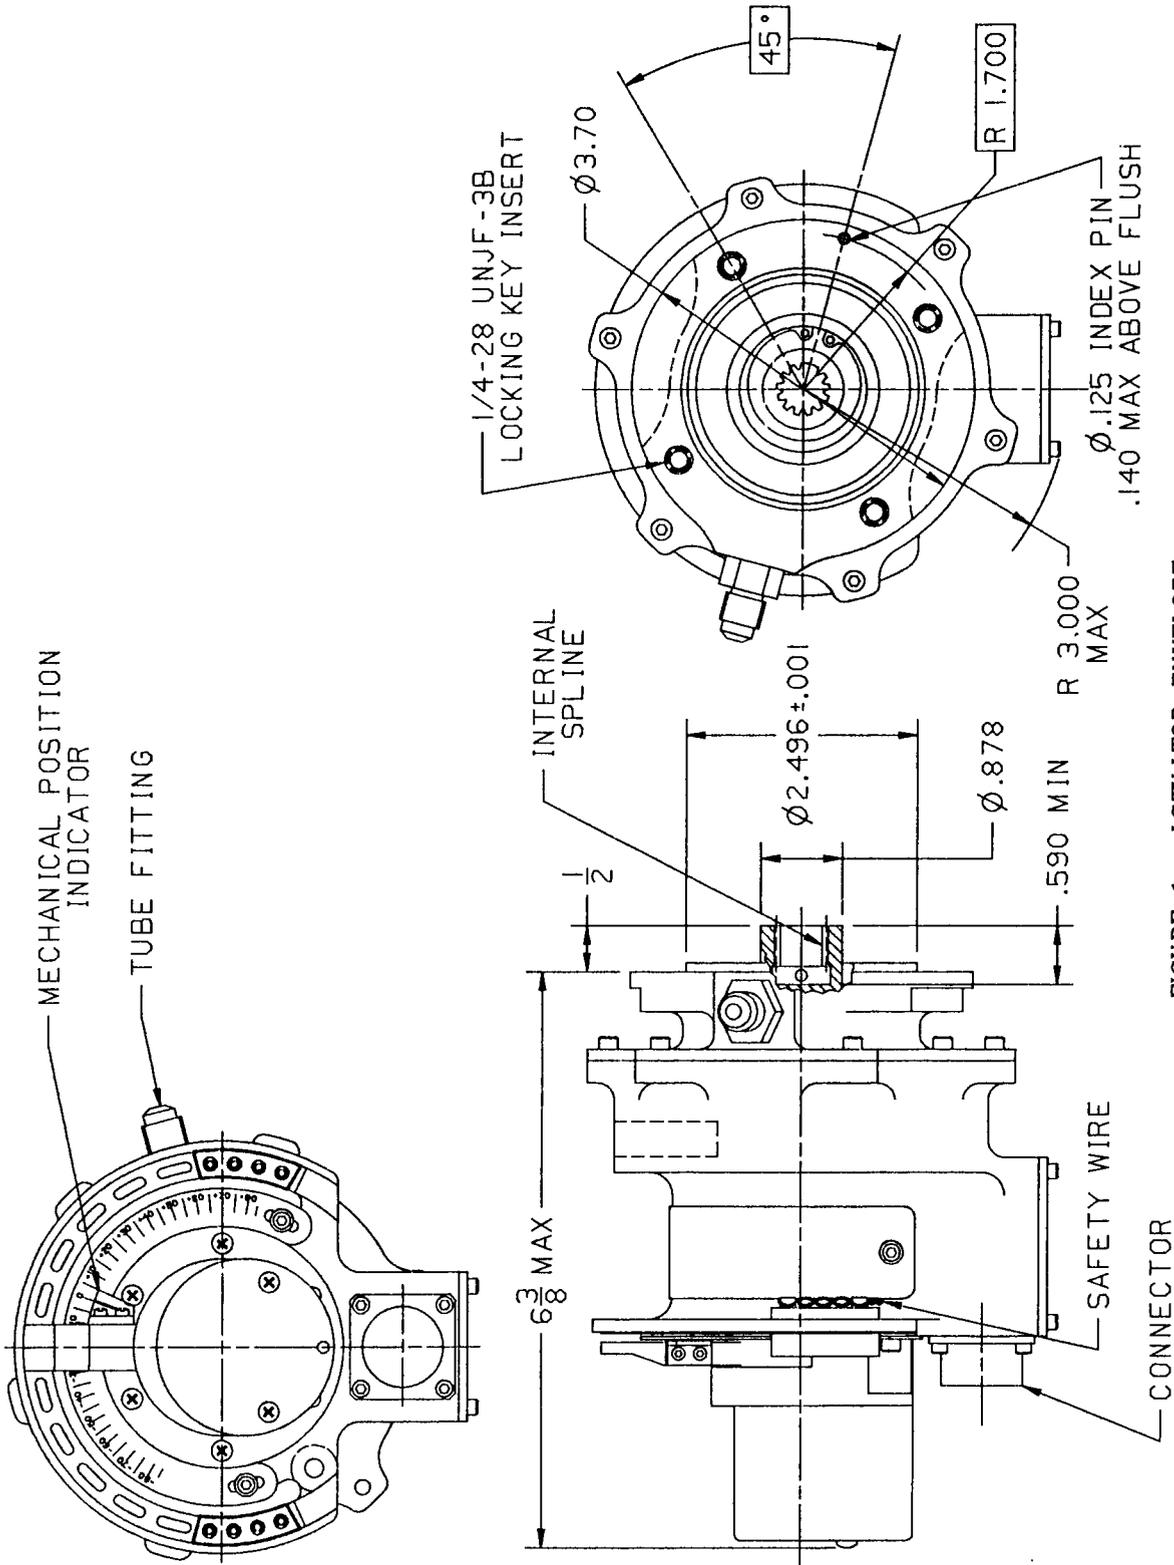
FIGURE 1. ACTUATOR ENVELOPE

The rotary actuator consists of a three-phase small-angle stepper motor, a Harmonic Drive gear reducer, a duplex bearing pair, dual-ganged instrumentation potentiometers, and associated hardware all mounted in an appropriate housing. The actuator envelope is given in Figure 1. A layout of the device is given in Figure 2.

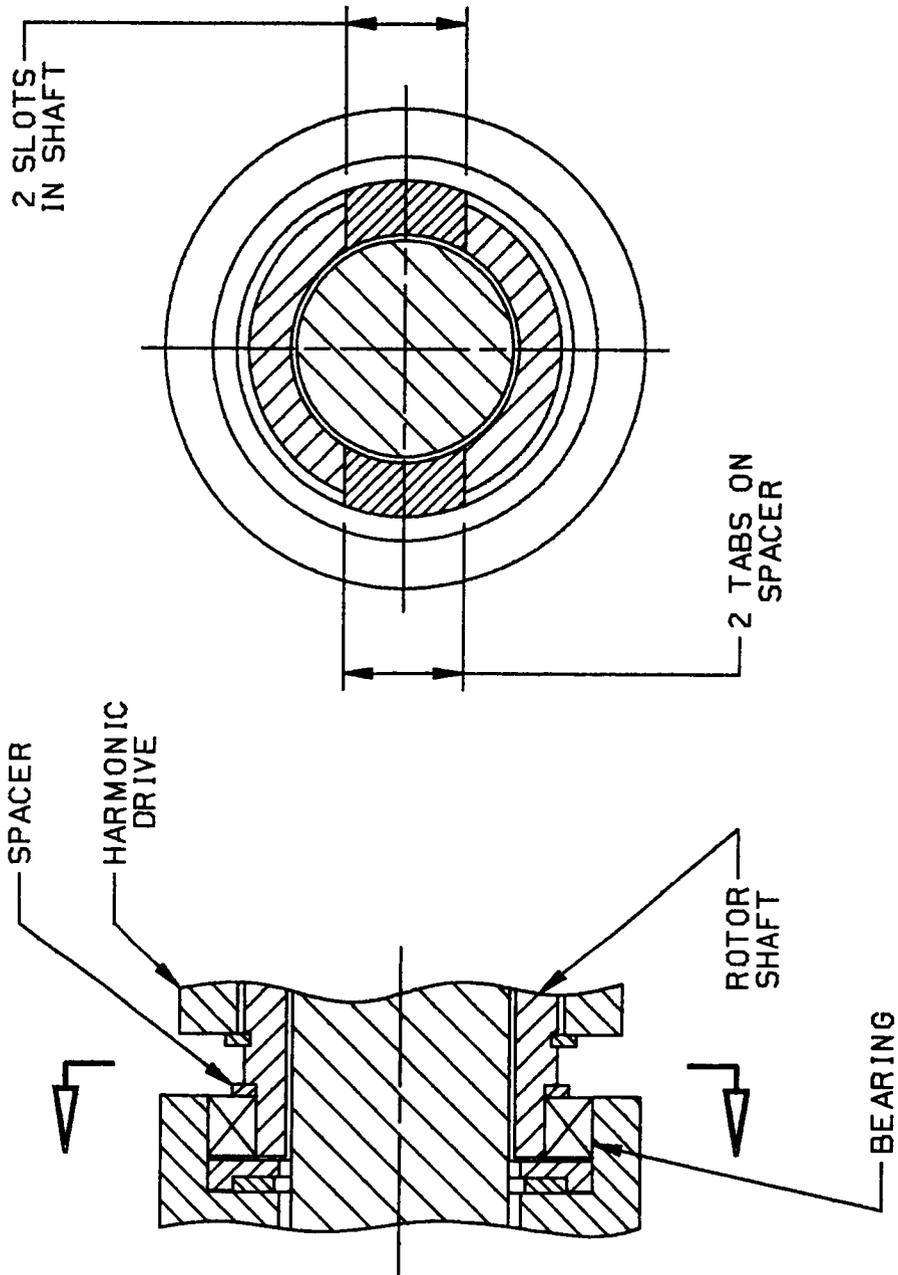
FIGURE 9. ROTOR SHAFT DETAIL

The problem of the bearing shoulder was corrected by inserting a high strength steel spacer between the bearing shoulder and the rotor shaft shoulder. Figure 3 shows the revised rear motor bearing configuration. The spacer has two tabs that are machined to tightly fit the slotted shaft. The purpose of these tabs is to stiffen the rotor shaft and limit its deflections.

The aluminum rotor shaft construction has slots machined along the axis of rotation, which transfer torque from the motor to the Harmonic Drive coupling. These slots reduced the shaft area moment of inertia and stiffness. Consequently, during vibration the shaft flexure contributed to the wear and degradation of the shaft bearing shoulder.

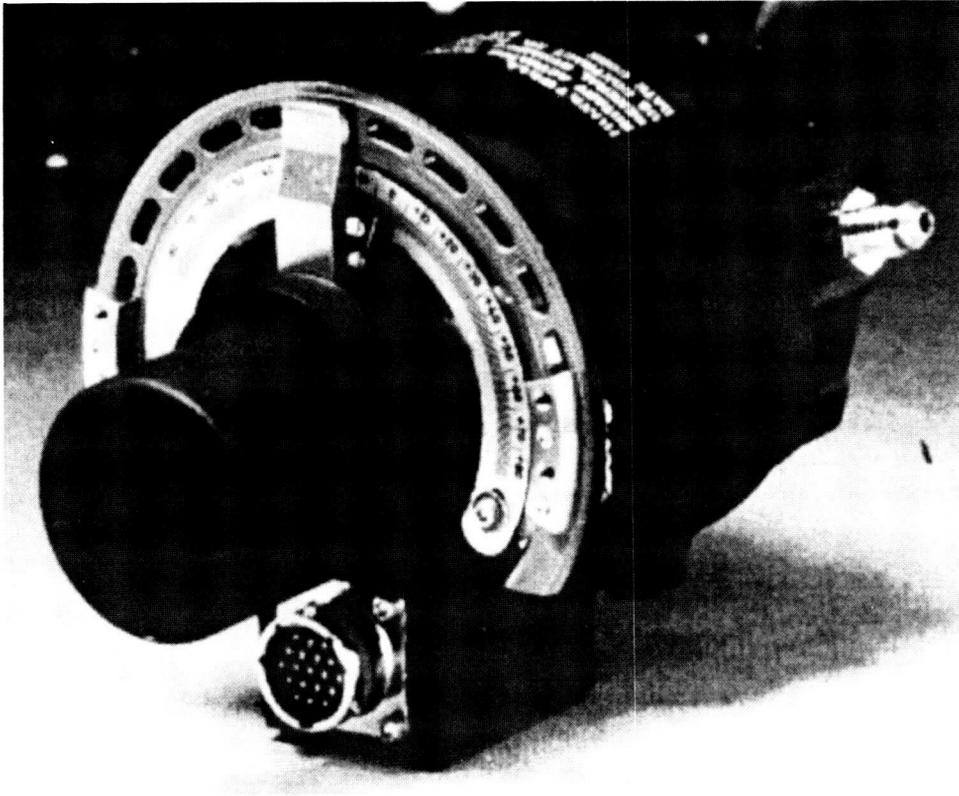
**FIGURE 4. ROTARY ACTUATOR 2961041**

This electromechanical rotary actuator, shown in Figure 4, has been successfully developed as the prime mover for a liquid oxygen valve. The unit is required to provide angular positioning of the liquid oxygen flow control valve on the Centaur Vehicle Rocket Engine. The application requirements are stringent. The unit must operate fully at cold temperatures and during vibration.
